Property Inspection Report

130 E. San Fernando St. #314, San Jose CA 95112

Inspected by:
Dan Pantoja
September 25, 2017
Report No. 2122

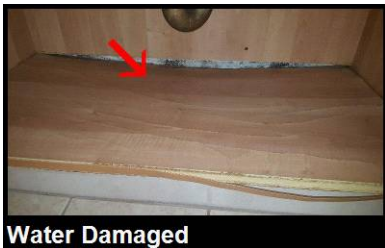
Action Recommended: The floor of the cabinet is water damaged. It is suggested that a pest control contractor be consulted for recommendations and corrective work. SEE PHOTO.

Water Damaged

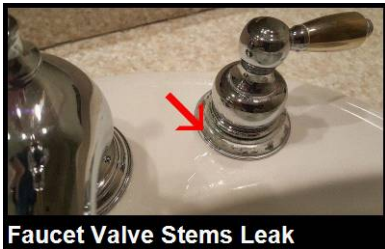
Action Recommended: The faucet valve stems leak at the sink basin. It is suggested that a licensed plumbing contractor be consulted for recommendations and corrective work. SEE PHOTO.

Faucet Valve Stems Leak

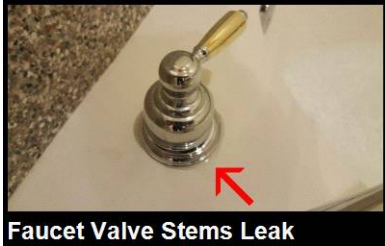
Action Recommended: The faucet valve stems serving the tub are leaking. It is suggested that a licensed plumbing contractor be consulted for recommendations and corrective work. SEE PHOTO.

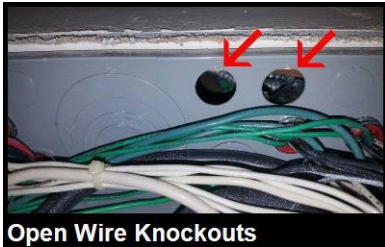
Action Recommended: There are open wire knockouts in the panel box. It is suggested that a licensed electrical contractor be consulted for recommendations and corrective work. SEE PHOTO.

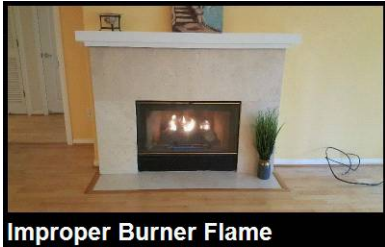
Action Recommended: The burner flame does not appear to be operating properly. It is recommended that an HVAC contractor be consulted for unit adjustment and further inspection. SEE PHOTO.

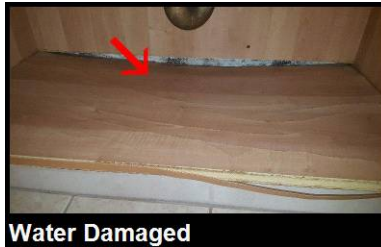
Action Recommended: The floor of the cabinet is water damaged. It is suggested that a pest control contractor be consulted for recommendations and corrective work. SEE PHOTO.

Water Damaged

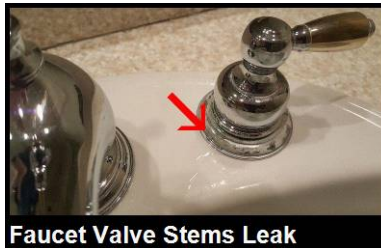
Action Recommended: The faucet valve stems leak at the sink basin. It is suggested that a licensed plumbing contractor be consulted for recommendations and corrective work. SEE PHOTO.

Faucet Valve Stems Leak

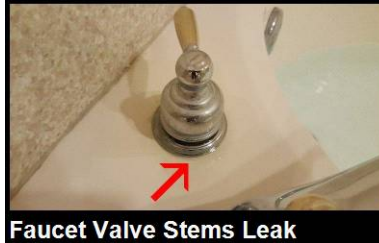
Action Recommended: The faucet valve stems serving the tub are leaking. It is suggested that a licensed plumbing contractor be consulted for recommendations and corrective work. SEE PHOTO.

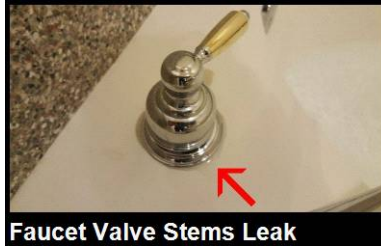
Action Recommended: The faucet valve stems serving the tub are leaking. It is suggested that a licensed plumbing contractor be consulted for recommendations and corrective work. SEE PHOTO.

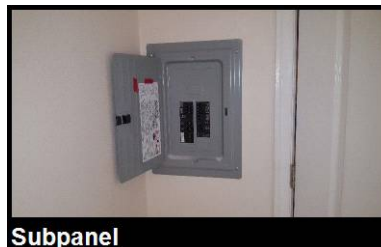
Subpanel

The electrical subpanel is located in the north bedroom. SEE PHOTO.

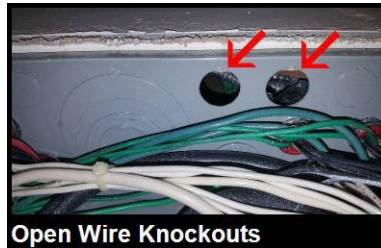
Action Recommended: There are open wire knockouts in the panel box. It is suggested that a licensed electrical contractor be consulted for recommendations and corrective work. SEE PHOTO.

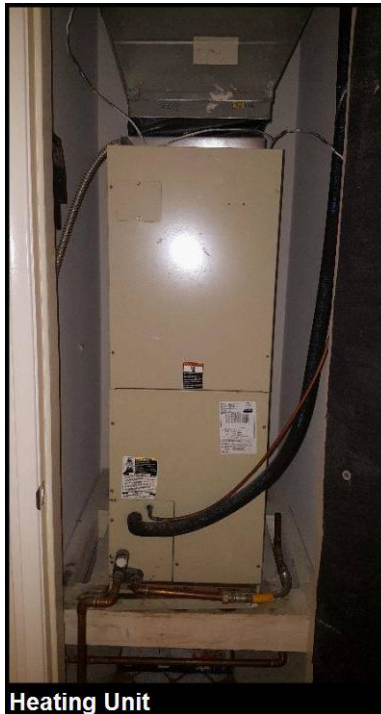
Heating Unit

The heating unit is located in a hallway utility closet.
SEE PHOTO.

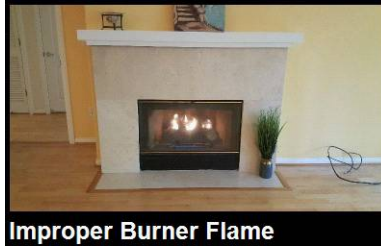
Action Recommended: The burner flame does not appear to be operating properly. It is recommended that an HVAC contractor be consulted for unit adjustment and further inspection. SEE PHOTO.

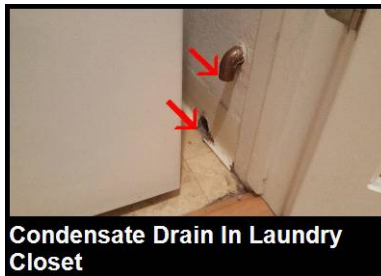
The condensate drain line is installed in the laundry closet which appears to be original construction. Periodic checking to make sure that the line is clear will help to maintain the system. SEE PHOTO.
